Contract #: 04-0120F4Cty: SF/ALA Rte: 80 PM: 13.2/13.9File #: 69.28**WELDING INSPECTION REPORT****Resident Engineer:**Pursell, Gary**Address:** 333 Burma Road**City:** Oakland, CA 94607**Report No:** WIR-004895**Date Inspected:** 25-Nov-2007**Project Name:** SAS Superstructure**OSM Arrival Time:** 1330**Prime Contractor:** American Bridge/Fluor Enterprises, a JV**OSM Departure Time:** 2230**Contractor:** Zhenhua Port Machinery Company, Ltd (ZPMC), Changxing Island **Location:** Shanghai, China

Bridge No: 34-0006**Component:** OBG Fabrication**Summary of Items Observed:**

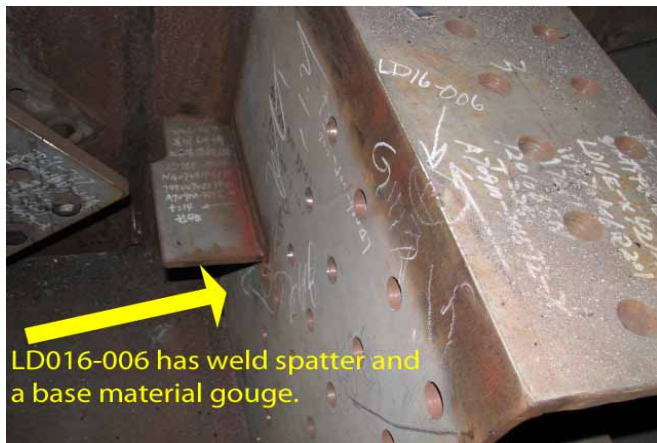
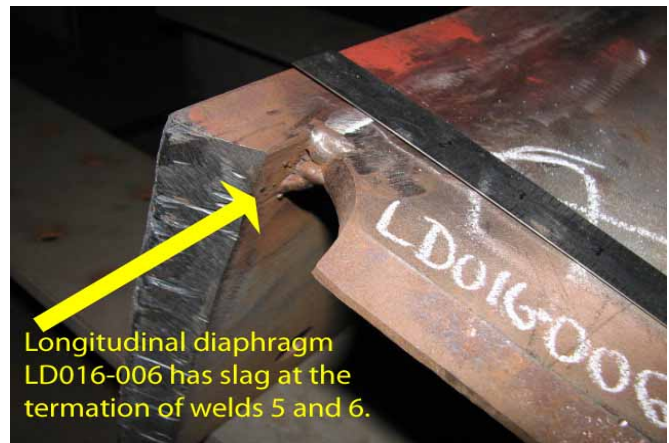
assembly bay #2 and Mr. Mah determined these welds are in OBG Bay #8. The QA Inspector accompanied Mr. Mah to OBG bay #8 where it was determined that these welds are not at this location. The QA Inspector asked ZPMC representative Mr. Shen Xue Jun, who had issued this “Notification of Witness Inspection” document to locate these welds and after walking to the back of assembly bay #2 Mr. Shen Xue Jun determined these longitudinal diaphragm assemblies are located inside the OBG near segment 5. The QA Inspector performed random visual inspection of longitudinal diaphragm weld LD016-006-006 and determined the termination of the weld contains slag and does not comply with AWS D1.5 specifications. The QA Inspector showed Mr. Shen Xue Jun the slag and Mr. Jun said this weld will be repaired. The QA Inspector performed random visual inspection of longitudinal diaphragm weld LD018-005-008 and determined the fillet weld does not comply with AWS D1.5 specifications due to insufficient weld size near the end of the weld termination. Mr. Shen Xue Jun said ZPMC will repair these welds. See the photographs below for additional information
